CERTIFIED LAND CORNER RECORDATION

ACCESSORY CORNERS IN SEC. 4 TWP. 31 N., R. 33 W., M.P.M.

Section 16 Twp. 31 N., R. 33W, M.P.M.

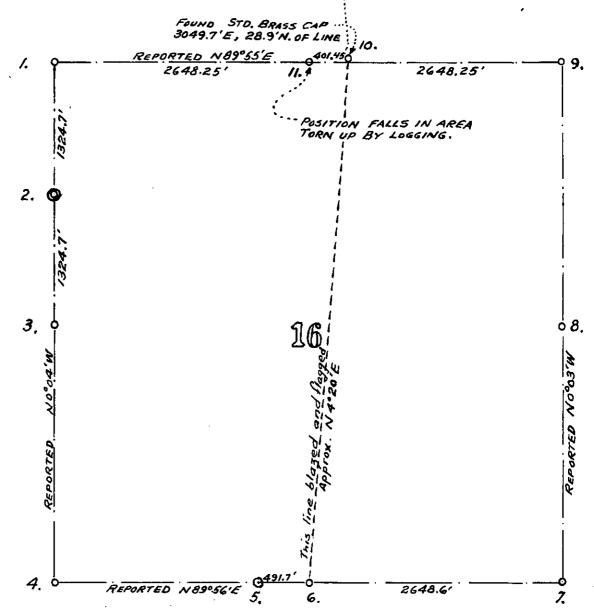
- 1. Standard brass cap with witnesses.
- 2. Set a 3/4" Pipe 18" long in a stone mound (on line at mid-point between NW Corner and position accepted as location of West $\frac{1}{4}$ Corner) from which a 24" larch bears S 37° Scribed 1/16 and posted with bearing tree location sign.

- 3. Corner not found but position confirmed by measurement and by illegible remains of bearing trees in reported locations.
- 4. Standard brass cap.
- 5. Stump of one bearing tree found. Corner not reset.

- 6. Bearing tree remains found and part of original post in position. = See below.
- 7. Standard brass cap.
- 8. Not searched for.
- 9. One bearing tree live, standing. One bearing tree down, legible but slid down hill from original position. We set a steel rod at position reported from live bearing tree. 10. FOUND STANDARD BRASS CAP. ADJUSTED TRANSIT TRAVERSE OF NORTH LINE OF SUBJECT SECTION

- POSITIONS THIS MONUMENT 401.45 FEET EAST AND 28.9 FEET NORTH OF MID-POINT BETWEEN CORNERS.
- 11. Corner not found Position falls in area torn up by logging operations. No bearing trees reported for original corner.

- * Set a squared cedar post, marked $\frac{1}{4}$ on east face from which, An 18" Fir bears S 1 E 18 feet. An 18" Fir bears S 1 $^{\circ}$ E 18 feet. A 12% Fir bears N $2\frac{1}{2}$ E $3\frac{1}{2}$ feet. Both marked $\frac{1}{4}$.
