LINCOLN COUNTY
DEPARTMENT OF ENVIRONMENTAL HEALTH
AFFIDAVIT OF WASTEWATER TREATMENT AND DISPOSAL SYSTEM COMPLIANCE REVIEW FOR SYSTEM INSTALLED, REPAIRED OR REPLACED WITHOUT A VALID PERMIT

Address or Location: 116 Kinklehorn Rd, Eureka, MT. 59917

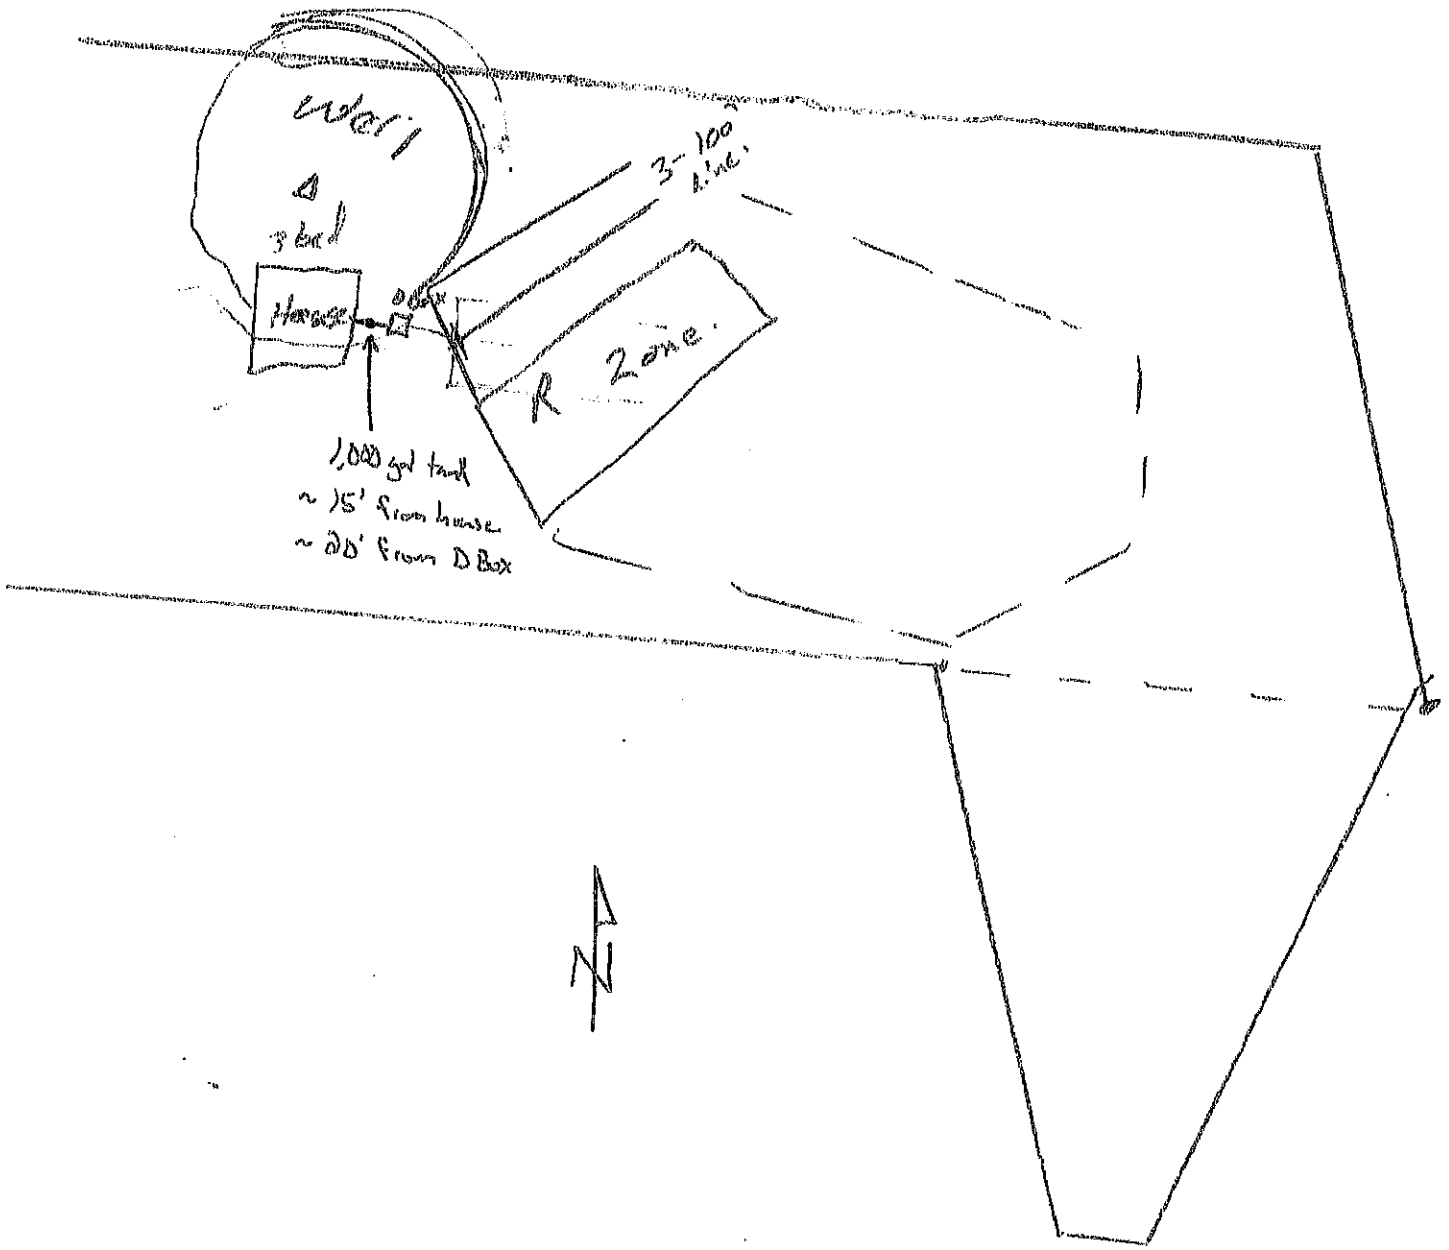
LOT LAYOUT

Water
3' bank
House
3- 100 ft. line
R 2 zone
1,000 gal tank
~ 15' from house
~ 28' from D Box
N
