## **CERTIFIED CORNER RECORDATION**

•					
Corner	C.O.E.	Sec.	20	T.	37N	R.	27W	P.M., MT	Lincoln	County
	5606/2									•

I. <u>1970 Corp. of Engineers Libby Dam Lake Koocanusa Cadastral District file No. E 53-1-154:</u> For corner no. 2 of tract 5606, set a standard U.S.C.E. disk, mkd. as shown:

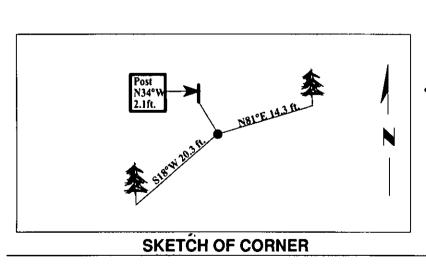
- II. Found a 3 1/2 in. diam., Corps of Engineers brass cap, set flush with the ground, in concrete, mkd. as shown above. No bearing trees found.
- III. Established two bearing trees and one steel fence post:

A pine, 15 ins. diam., bears S18°W, 20.3 ft. dist., mkd. "COE 5606/2".

A pine, 8 ins. diam., bears N81°E, 14.3 ft. dist., mkd. "X" on snowblaze "BT".

A 3 ft. tall, steel fence post, bears N34°E, 2.1 ft. dist. from the corner.
