CERTIFIED CORNER RECORDATION

Corner: Section Corner; Secs. 21, 22, 27 & 28

T. <u>26N.</u>

R. 28W. P.M.M. Lincoln County

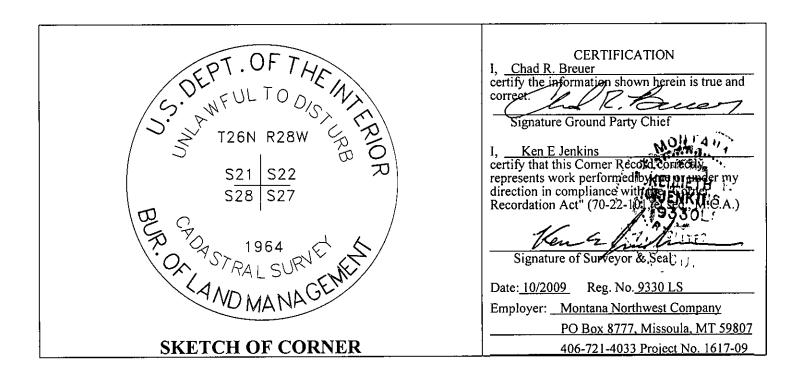
We find a standard BLM monument with a 3 1/4" BLM brass cap, 12" above the ground,

leaning and firmly set, marked as shown below, from which:

A 20" fir, bears N58 1/4°E, 7.9 ft., with partially overgrown blaze

A 21" fir bears S39°W 9.9 ft., with an overgrown blaze A 13" spruce bears S32°E 13.9 ft., with an overgrown blaze An 11" spruce bears N74°W 17.2 ft., with visible scribing

We leave monument as found.

We set a galvanized steel with USFS decals P54-1 & P71-10, west of monument. We paint red bands on the bearing trees, and attached USFS signs 54-3 & 54-9 as needed.
