## CERTIFIED CORNER RECORDATION

Corner C-E 1/16 Section 9 T. 26 N R. 29 W P.M.M. Lincoln

Date of Work: October 8th, 1982

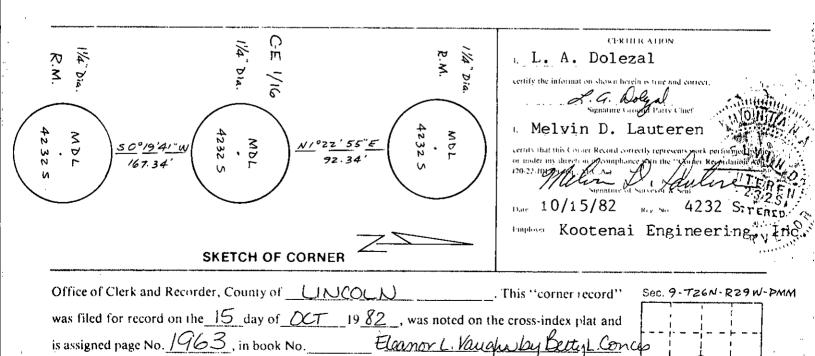
- 1. No previous record.
- 2. No previous evidence found.
- 3. Set a 5/8 inch diameter x 24 inch long steel rebar with a  $1\frac{1}{4}$ inch diameter yellow PVC Plastic Cap stamped: MDL 4232 S for the C-E 1/16th Corner.

Corner falls in mowed hay field/pasture with no bearing trees available, therefore the following reference monuments were set:

from C-E 1/16th,  $N1^{\circ}22'55$ "E, 92.34 feet, set a 5/8" x 24" steel rebar with yellow cap stamped: MDL 4232 S, bent to North.

from C-E 1/16th,  $S0^{O}19'41"W 167.34 feet, set a <math>5/8" \times 24"$ steel rebar with yellow cap stamped: MDL 4232 S, bent to East.

Both reference monuments set 3-4 inches under existing gravel of the Houghton Creek Road No. 6761.
