## CERTIFIED CORNER RECORDATION

Corner C-N-NW-SE 1/256 Sec. 9T. 26N., R. 29W., P.M.M. Lincoln County

Date of work: January, 1983

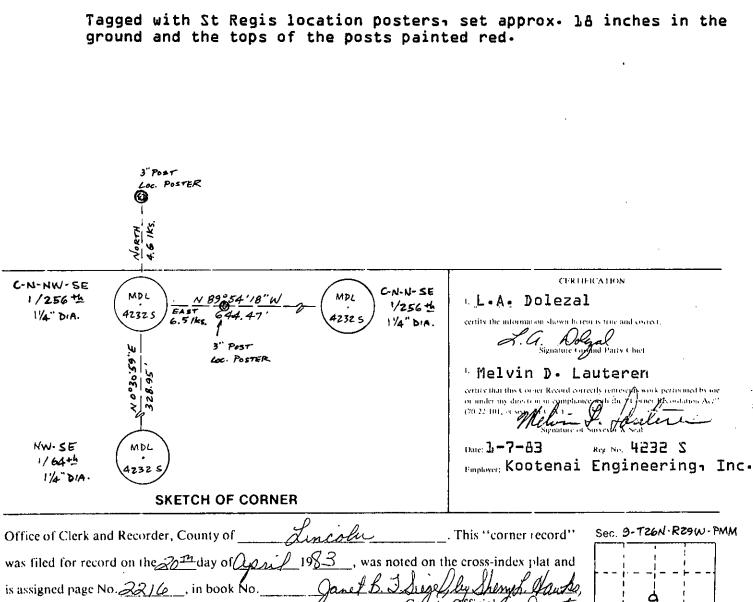
- No previous record. 1 .
- 2. No previous evidence found.
- Set a 5/8 inch diameter X 24 inch long steel rebar with a 1/4 inch Э. diameter yellow PVC Plastic Cap stamped: MDL 4232 S for the C-N-NU-SE 1/256 corner.

No bearing trees were readily available. Corner falls on the North bank of the Pleasant Valley Fisher River running through a seasonal boggy area with heavy brush and small deciduous growth.

A 5 foot long X 3 inch diameter treated post bears North, 4.6 links

A 5 foot long X 3 inch diameter treated post bears East, 6.5 links distant.
