CERTIFIED CORNER RECORDATION 5 1/16th

Corner Section 22 + Section 23 T. 27N., R. 30W., P.M.M. Lincoln County

Date of Work: 9/15/83

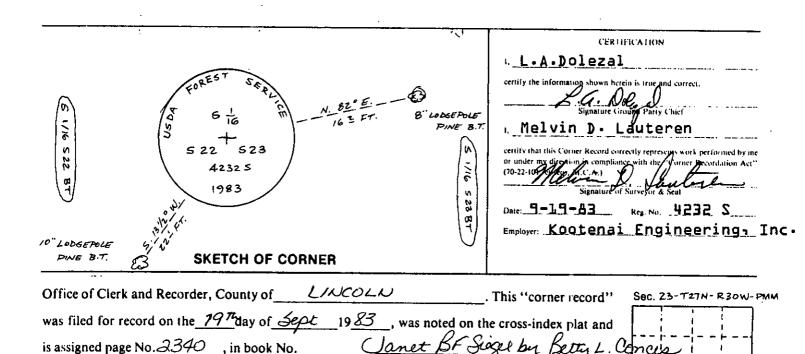
- <u>l</u>. No previous record.
- 2. No evidence found.
- Set a 2 1/2 inch diam. X 30 inch long Aluminum Post with lower half Э. crimped and with a 3 1/2 inch diam. Aluminum Cap marked as shown below in sketch of corner; set 6 to 9 inches, more or less, above ground with small dirt mound around corner; no rock readily available; corner painted red with blue flagging tied around it.

- A Lodgepole Pine, 10 inches in diam., bears S. 13 1/20 W., 22.1 feet distant, marked: S 1/16 S22 BT
- A Lodgepole Pine, A inches in diam., bears N. 82° E., 16.2 feet distant, marked: \$ 1/16 \$23 BT

Bearing trees tagged with U.S.F.S. interior location posters; with faces of scribed blazes and snow blazes painted red and red ring painted above tags.

NOTE: Corner falls on gentle slope in the bottom of the main drainage of Miller Creek approximately 300-310 feet South of the main Miller Creek Road, North of Miller Creek.
