CERTIFIED CORNER RECORDATION		
Сс	orner 5 HES 825 T. 30 N., R. 28 W., P.M.M. Lincoln Count	
•	1919 HES 825 record by W. P Stephenson: Place a small stone marked with a cross (X) under a limestone, 40x12x5 ins., 30 ins. in the ground, marked 5 HES 825 on the N face, and a cross (X) on top for the exact corner point, from which:	
	A cross (X) on a pine tree, 20 ins. diam., bears N $54^{\circ}51$ 'E, 35 lks. dist. A cross (X) on a pine tree, 16 ins. diam., bears N $2^{\circ}28$ 'E, 13 lks. dist., each blazed and scribed 5 HES 825 BT.	
	Raise a mound of stone 4 ft. base, 2 ft. high, North of the corner.

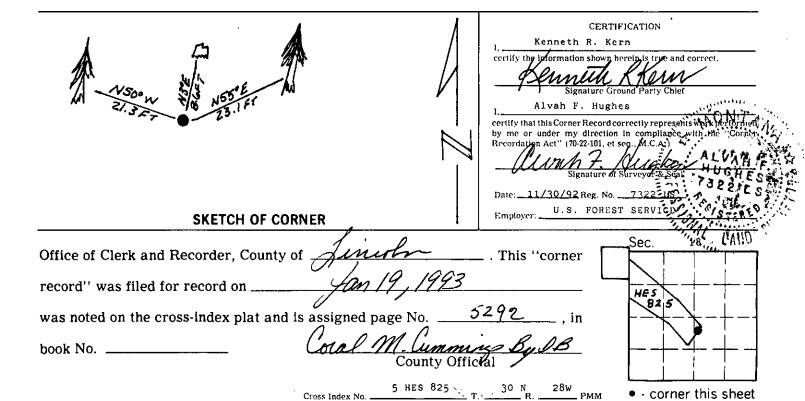
1.	Found a stone, 10 ins. above the ground, mkd. 5 HES 825 on the N face and an X on top, firmly set in place, with a mound of stone to the North, from which:	
	A pine stump, 20 ins. diam., bears N $\overset{\circ}{3}$ E, 8.6 ft. (13 lks.) dist., mkd. 5 HES 825 BT. A pine, 31 ins. diam., bears N $\overset{\circ}{55}$ E, 23.1 ft. (35 lks.) dist., mkd. 825 B.	
II.	Establised one new bearing tree:	
	A fir, 7 ins. diam., bears N 50 $^{\circ}$ W, 21.3 ft. dist., mkd. 5 HES 825 BT.	
	Painted red bands around the bearing trees and attached Land Survey Monument and Bearing Tree signs.	
	Set a 6 ft. galvanized steel guard post with Land Survey Marker and Property Boundary decals, N 34 E, 3 ft.	
	Magnetic declination: 20 East
