## CERTIFIED CORNER RECORDATION

Corner \_\_\_ E 1/4 of Sec. 8 T. 31 N., R. 33 W., P.M.M. Lincoln County

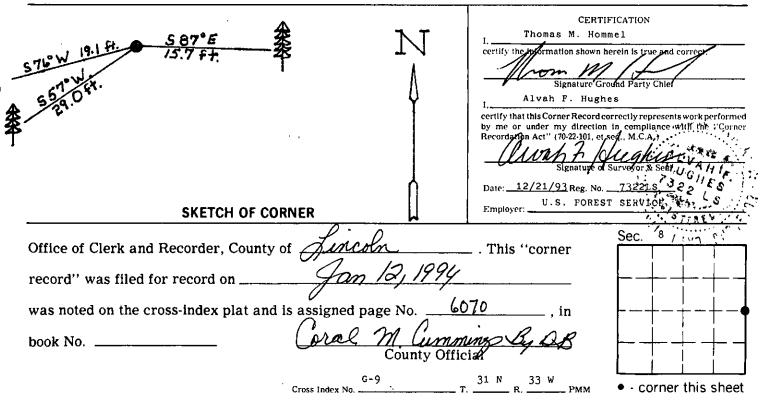
II. Found a 2 1/2 in. diam. iron pipe, pushed over by logging activity, with 3 1/2 in. B.L.M. brass cap mkd. as shown above, from which:

A pine stump, 16 ins. diam., bears  $876^{\circ}$ W, 19.1 ft. (28.9ks.) dist., "1/4" visible.

A larch, 10 ins. diam., bears  $887^{\circ}E$ , 15.7 ft. (23.7 lks) dist., healed face.

A fir, 10 ins. diam., bears \$57 W, 29.0 ft. (43.9 lks.) dist., healed face.

III. Straightened pipe to original position and verified by found bearing trees.

Painted a red band around bearing trees and attached Land Survey Monument and Bearing Tree signs.
