CERTIFIED CORNER RECORDATION

Corner SMC-east line Gov't Lot 5 T. 33N R. 34W P.M.M. Lincoln

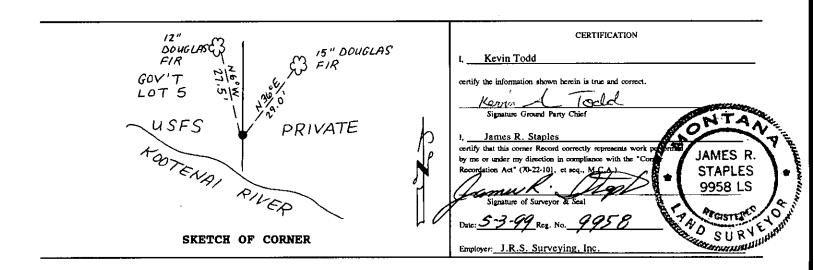
- No records found at Lincoln County Courthouse. 11
- No evidence found on the ground. 2)
- The position as determined by survey for the W-W-W1/256 corner was found to be below the Ordinary High water mark of the Kootenai River- at a point 20' north of the computed position on the east line of Government Lot 5, safely above the High Bank, set a 5/8" x 31 30" rebar, with a 34" aluminum cap, marked as shown:

From which:

A 15" Douglas Fir, bears N36°E, 29.0' distant and scribed S17 SMC BT. A 12" Douglas Fir, bears N 6°W, 27.5' distant and scribed S17 SMC BT.

Blazes and scribing on bearing trees were painted red. Bearing tree tags and Land Survey Monument signs were attached to trees. A 6' steel post with Land Survey Monument and Forest Service Property Boundary decals attached was placed 1' south of monument.
